Design Guide

for Improving School Safety
in Earthquakes, Floods, and High Winds

6 Making Schools Safe From High Winds

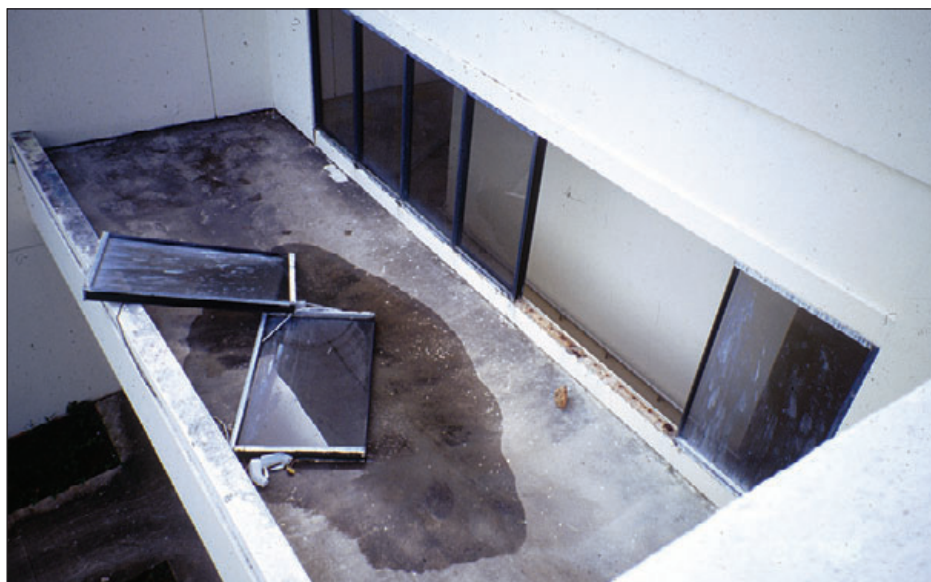
Figure 6-50:
Two complete windows, including frames, blew out as a result of an inadequate number of fasteners. Typhoon Paka (Guam, 1997)

The IBC requires that windows, curtain walls, and skylight assemblies (i.e., the glazing, frame, and frame attachment to the wall or roof) have sufficient strength to resist the positive and negative design wind pressure (see Figure 6-50). Design professionals should specify that these assemblies

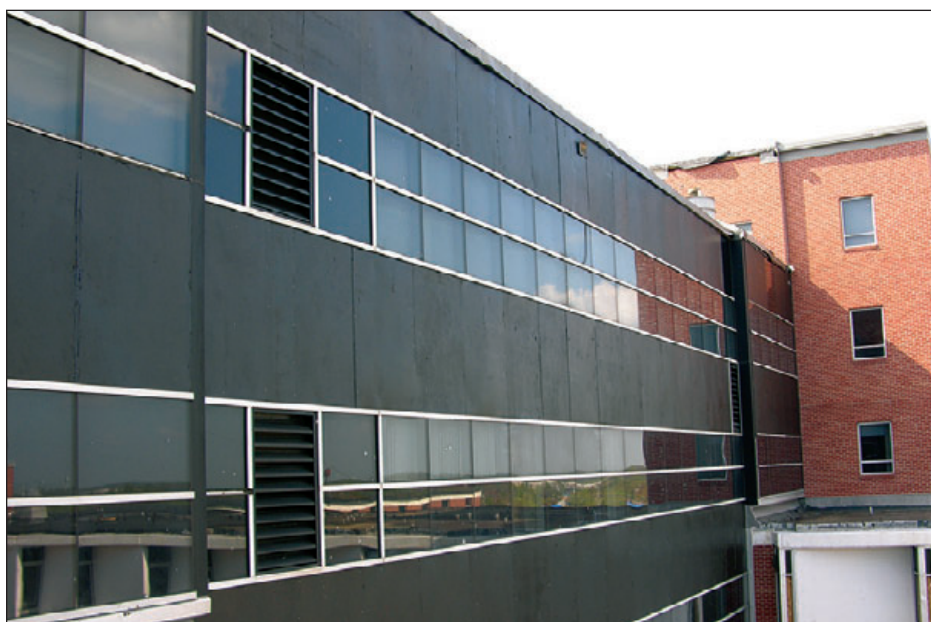
Figure 6-53:
Plywood panels (black continuous bands) installed after the glass spandrel panels were broken by roof aggregate.¹⁹ Estimated wind speed: 130 mph. Hurricane Katrina (Mississippi, 2005)

Exterior glazing that is not impact-resistant (such as laminated glass or polycarbonate) or protected by shutters is extremely susceptible to breaking if struck by wind-borne debris. Even small, low-momentum missiles can easily break glazing that is not protected. At the building shown in Figure 6-53, approximately 400 windows were broken. Most of the breakage was caused by wind-blown aggregate from the building's aggregate-ballasted single-ply membrane roofs, and aggregate from built-up roofs. With broken windows, a substantial amount of water can be blown into a building, and the internal air pressure can be greatly increased, which may damage the interior partitions and ceilings.

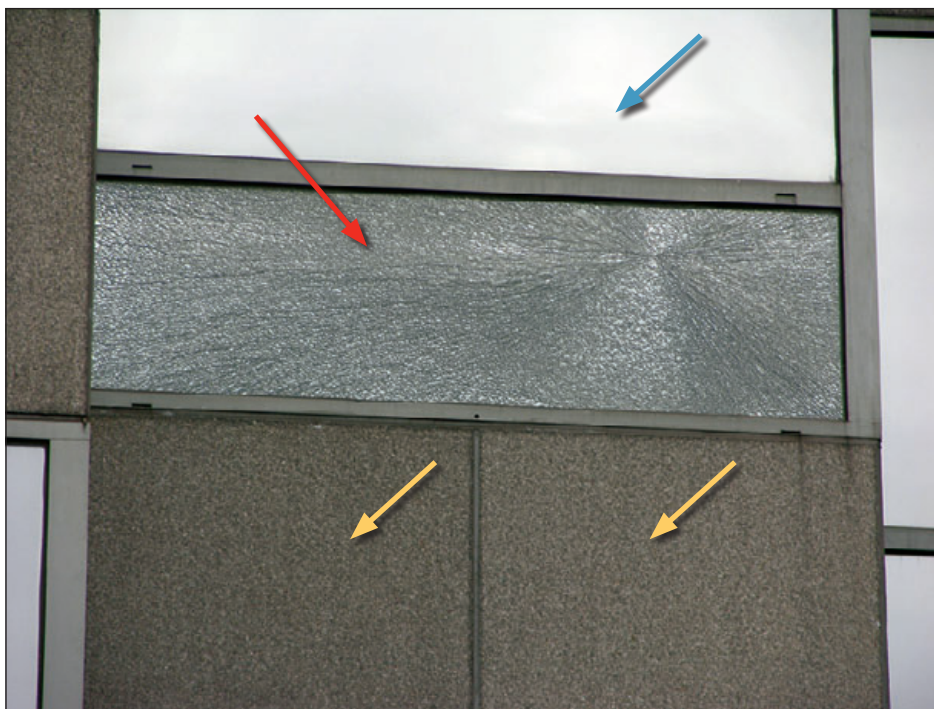
Figure 6-54: The red arrow shows a piece of laminated glass that was broken, but remained in the frame to protect the building's interior. The blue arrow shows unbroken laminated glass. The yellow arrows show granite wall panels. Estimated wind speed: 105 mph. Hurricane Katrina (Louisiana, 2005)

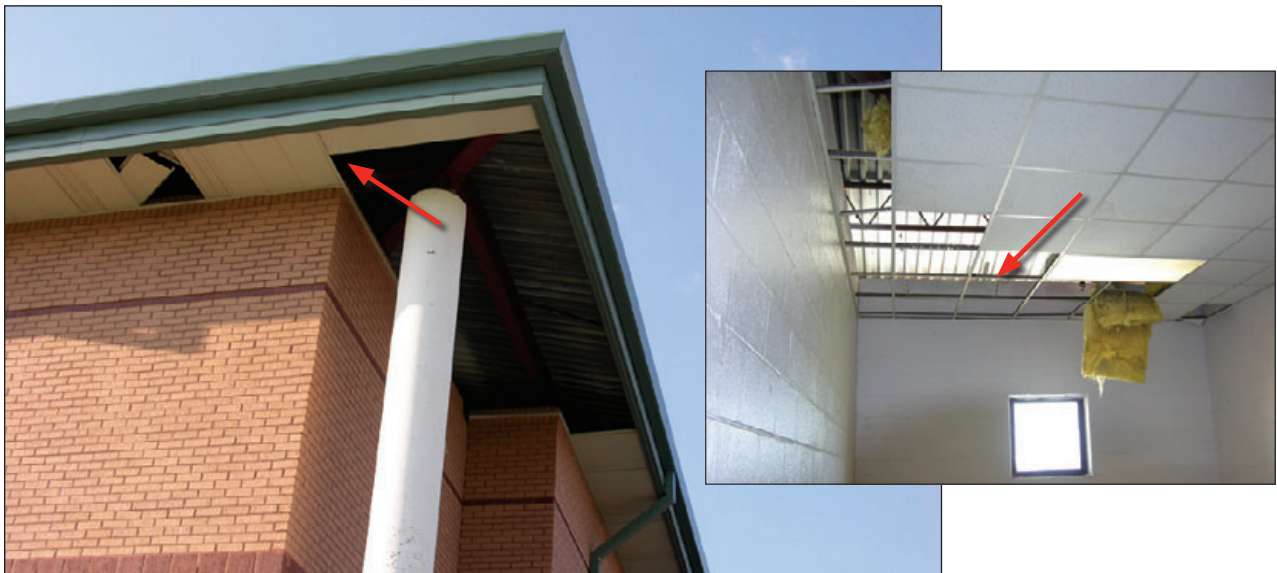
Figure 6-55:

The exterior wall stopped just above the soffit (red arrows). After the metal soffit panels blew away, wind-driven rain blew into the attic space, which saturated the fiberglass batt insulation and caused the ceiling boards to collapse. Estimated wind speed: 130 mph. Hurricane Katrina (Mississippi, 2005)

Besides the cost of repairing the damaged soffits, wind-borne soffit debris can cause property damage and injuries. Failed soffits may also provide a convenient path for wind-driven rain to enter the building, as illustrated by Figure 6-55. This school had a steep-slope roof with a ventilated attic space. The exterior CMU/brick veneer wall stopped just above the soffit (red arrows at Figure 6-55). Wind-driven rain entered the attic space where the soffit had blown away. This and other storm-damage research has shown that water blown into attic spaces after the loss of soffits can cause significant damage and the collapse of ceilings. Even in instances where soffits remain in place, water can penetrate through soffit vents and cause damage.

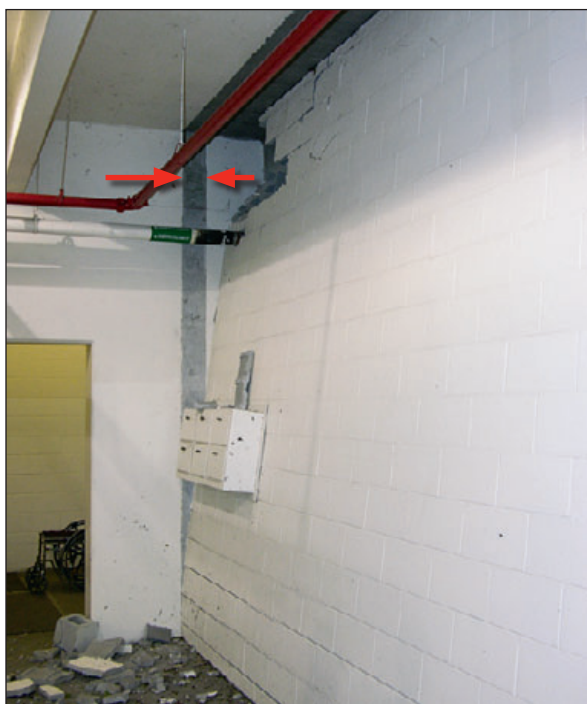
Figure 6-56:
The red arrows show the original location of a CMU wall that nearly collapsed following a rolling door failure. Estimated wind speed: 140–160 mph. Hurricane Charley (Florida, 2004)

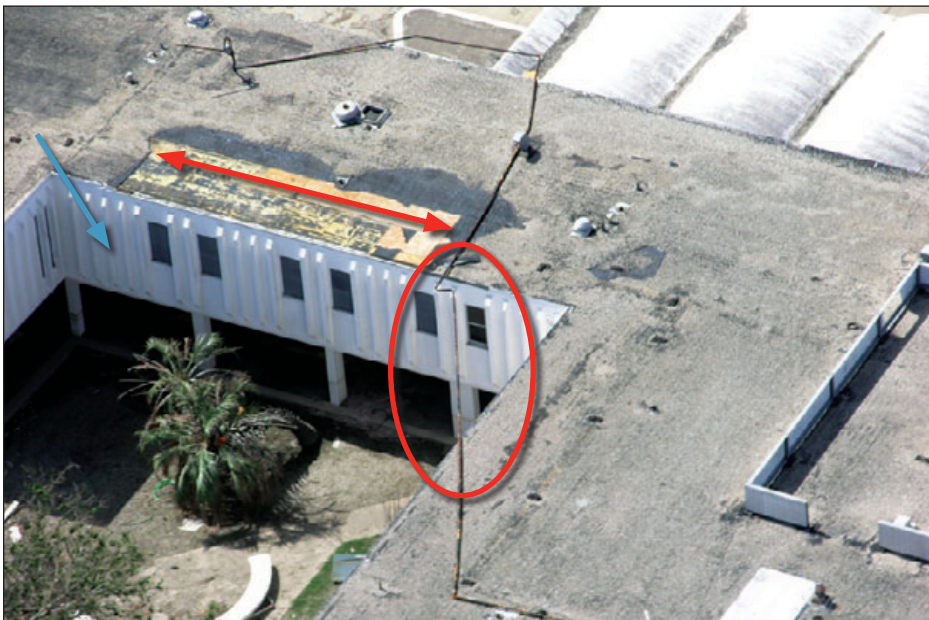
Figure 6-57: Although uncommon for schools, precast wall panels were attached to the structural frame of this school. This type of wall typically offers excellent wind performance. Note the roof covering damage and displaced gas line. Estimated wind speed: Approximately 125–130 mph. Hurricane Katrina (Louisiana, 2005)

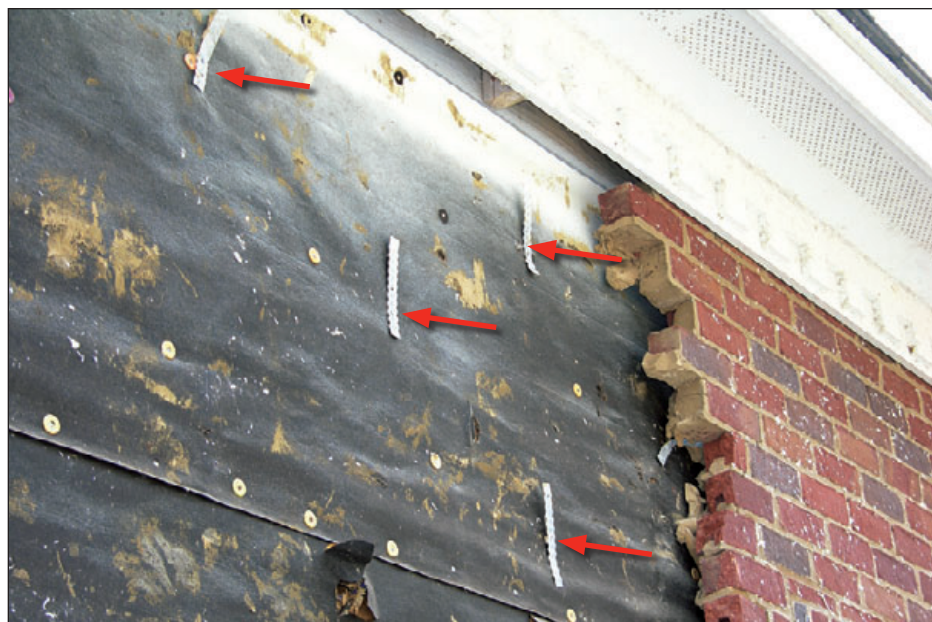
Figure 6-58:
The four ties shown by the red arrows were not embedded into the mortar. Estimated wind speed: 105 mph. Hurricane Katrina, (Mississippi, 2005)

Brick veneer: Brick veneer is frequently blown off walls during high winds. When brick veneer fails, wind-driven water can enter and damage buildings, and building occupants can be vulnerable to injury from wind-borne debris (particularly if the walls are sheathed with plastic foam insulation or wood fiberboard in lieu of wood panels). Pedestrians in the vicinity of damaged walls can also be vulnerable to injury from falling veneer. Common failure modes include tie (anchor) fastener pull-out, failure of masons to embed ties into the mortar (Figure 6-58), poor bonding between ties and mortar, a mortar of poor quality, and tie corrosion.

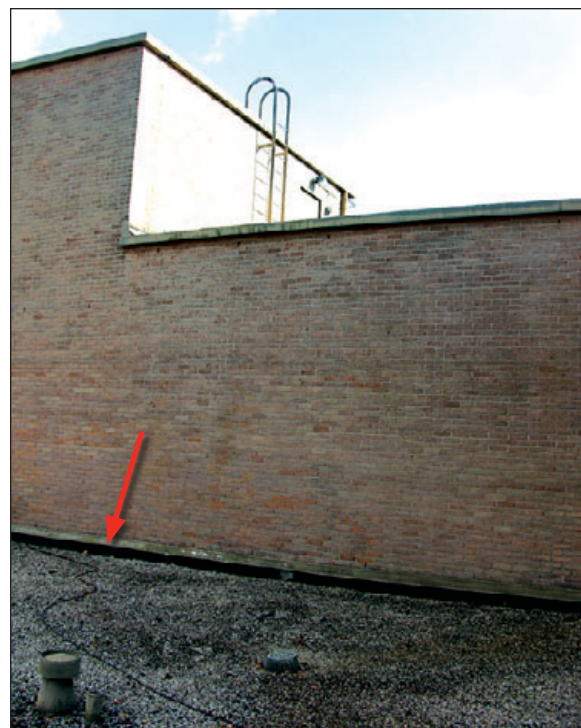
Figure 6-59:
Water leaked inside along the base of the brick veneer walls (red arrow). Estimated wind speed: 115 mph. Hurricane Katrina (Louisiana, 2005)

To avoid water leaking into the building, it is important that weep holes be adequately spaced and not be blocked during brick installation, and that through-wall flashings be properly designed and installed. When the base of the brick veneer occurs near grade, the grade should be designed so that it occurs several inches below the weeps so that drainage from the weeps is not impeded. Also, landscaping should be kept clear of weeps so that vegetation growth does not cause blockage of weeps. At the building shown in Figure 6-59, water leaked into the building along the base of many of the brick veneer walls. When high winds accompany heavy rain, a substantial amount of water can be blown into the wall cavity.

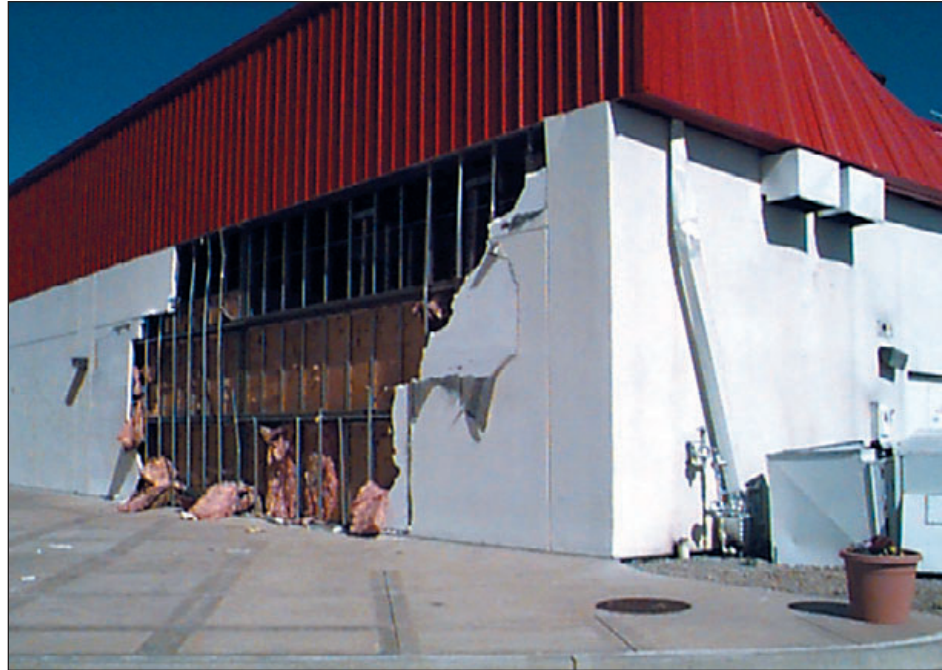
Figure 6-61:
EIFS blow-off near a wall corner. At one area, the metal fascia was also blown in.

EIFS: Figure 6-60 shows typical EIFS assemblies. Figure 6-61 shows EIFS blow-off. In this case, the molded expanded polystyrene (MEPS) was attached to gypsum board, which in turn was attached to metal studs. The gypsum board detached from the studs, which is a common EIFS failure mode. When the gypsum board on the exterior side of the studs is blown away, it is common for gypsum board on the interior side to also be blown off. The opening allows the building to become fully pressurized and allows the entrance of wind-driven rain. Other common types of failure include wall framing failure (see Figure 6-63), separation of the MEPS from its substrate, and separation of the synthetic stucco from the MEPS.

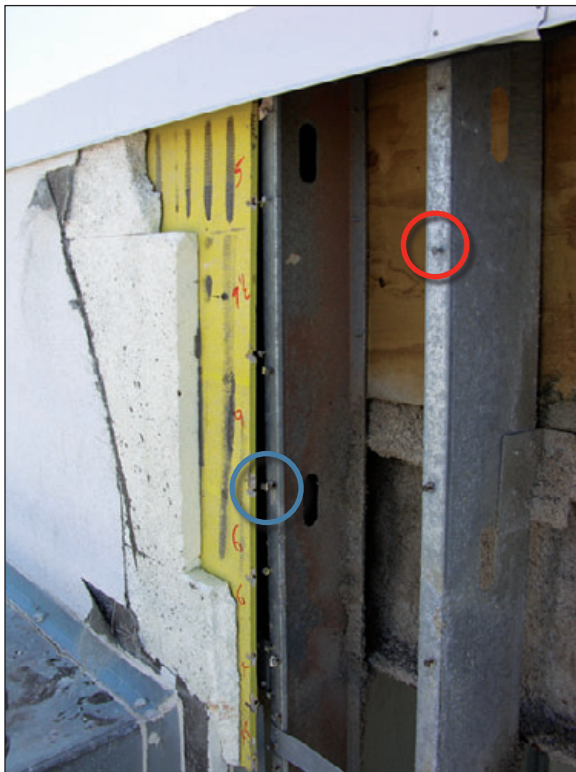
Figure 6-62:

Reliable wind performance of EIFS is very demanding on the designer and installer. It is particularly important to attach the gypsum board with a sufficient number of properly located fasteners and to properly apply the adhesive. At the newly constructed building shown in Figure 6-62, several of the gypsum boards blew off because of an inadequate number of screws. Also, at the gypsum board joint, there was insufficient fastener edge distance. Although not the primary failure mode, the adhesive between the MEPS and gypsum board was applied in rows, rather than continuously over the entire substrate with a notched trowel.

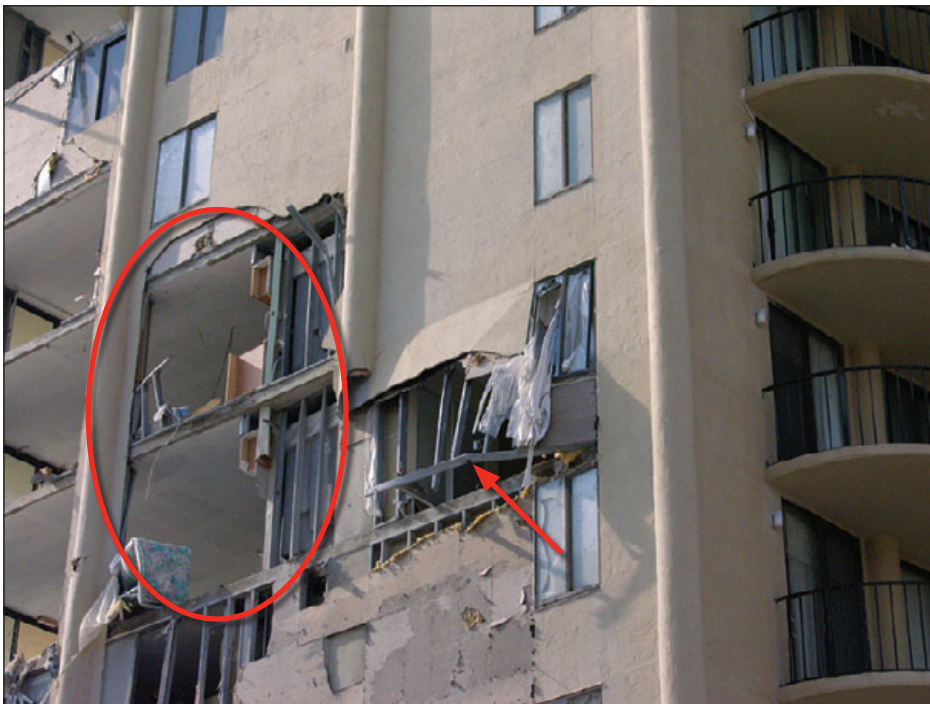
Figure 6-63:
The stucco wall failure was caused by inadequate attachment between the stud tracks and the building's structure. All of the metal stud framing within the red oval blew away. The arrow shows a bottom stud track that detached and pulled away from the building. Estimated wind speed: 110–125 mph. Hurricane Ivan (Florida, 2004)

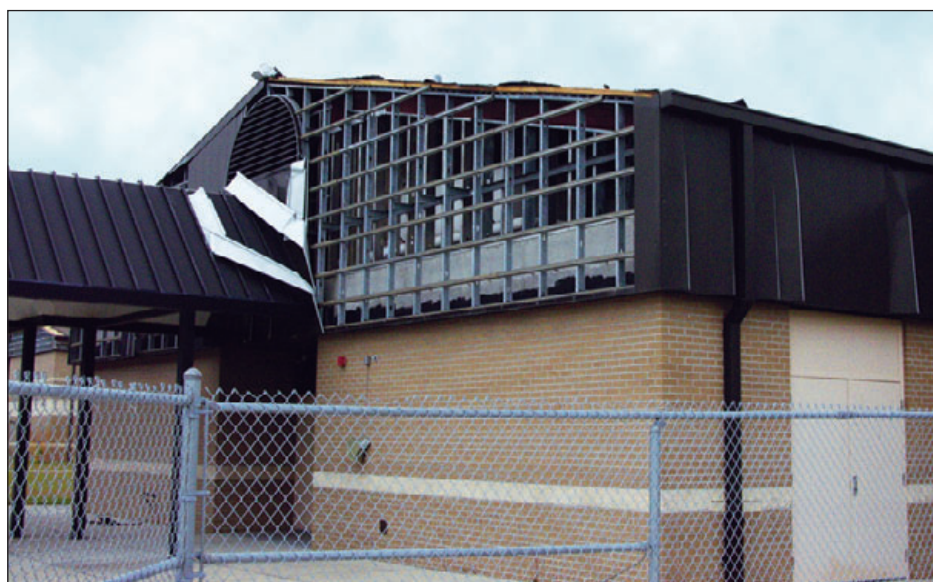
Figure 6-64:
The loss of metal wall panels allowed a substantial amount of wind-driven rain to penetrate into the classroom. Estimated wind speed: 105–115 mph. Hurricane Ivan (Florida, 2004)

Metal wall panel performance also depends on adequacy of the framing to which it is attached. At the school shown in Figure 6-65, the metal fascia panels were attached to wood furring that was inadequately attached to CMU. Unlike the condition at the school shown at Figure 6-64, with the CMU behind the metal panels, water was prevented from entering the school. However, wind-borne fascia debris can cause damage or cause injury.

metal wall panels shown in Figure 6-64 been applied over a moisture barrier and sheathing, the amount of water entering the school would have likely been eliminated or greatly reduced, as is the case with the school shown in Figure 6-65.

Parapets: For low-sloped roofs, minimum 3-foot high parapets are recommended. With parapets of this height or greater, the uplift load in the corner region is substantially reduced (ASCE 7 permits treating the corner zone as a perimeter zone). Also, a high parapet (as shown in Figure 6-106) may intercept wind-borne debris and keep it from blowing off the roof and damaging other building components or injuring people. To protect base flashings from wind-borne debris damage and subsequent water leakage, it is recommended that metal panels on furring strips be installed over the base flashing (Figure 6-88). Exposed stainless steel screws are recommended for attaching the panels to the furring strips, because using exposed fasteners is more reliable than using concealed fasteners or clips (as were used for the failed panels shown in Figure 6-64).

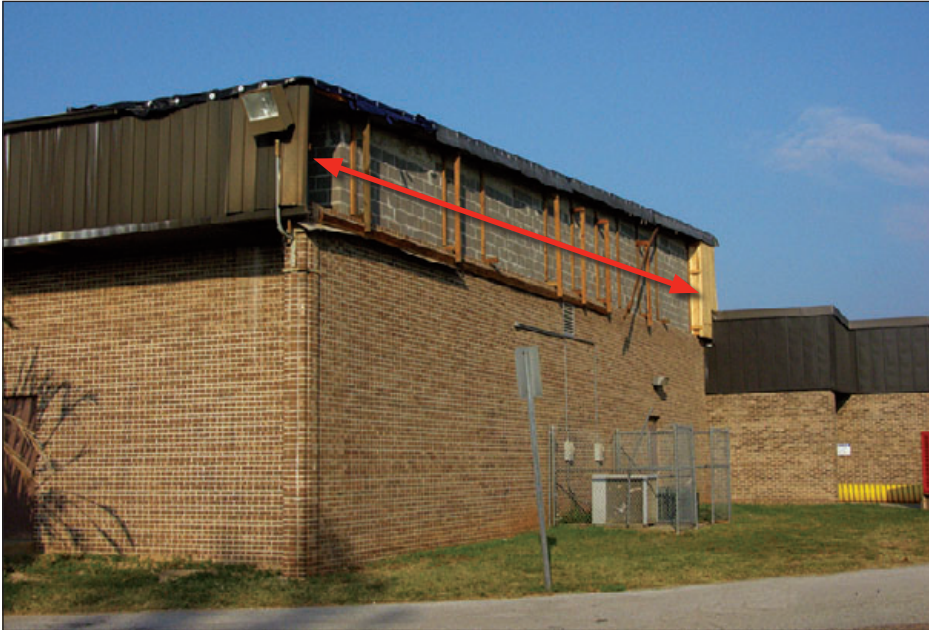
Figure 6-65:
Blow-off of metal fascia panels due to inadequate attachment of wood furring to the CMU wall. Estimated wind speed: 85–95 mph. Hurricane Ivan (Florida, 2004)

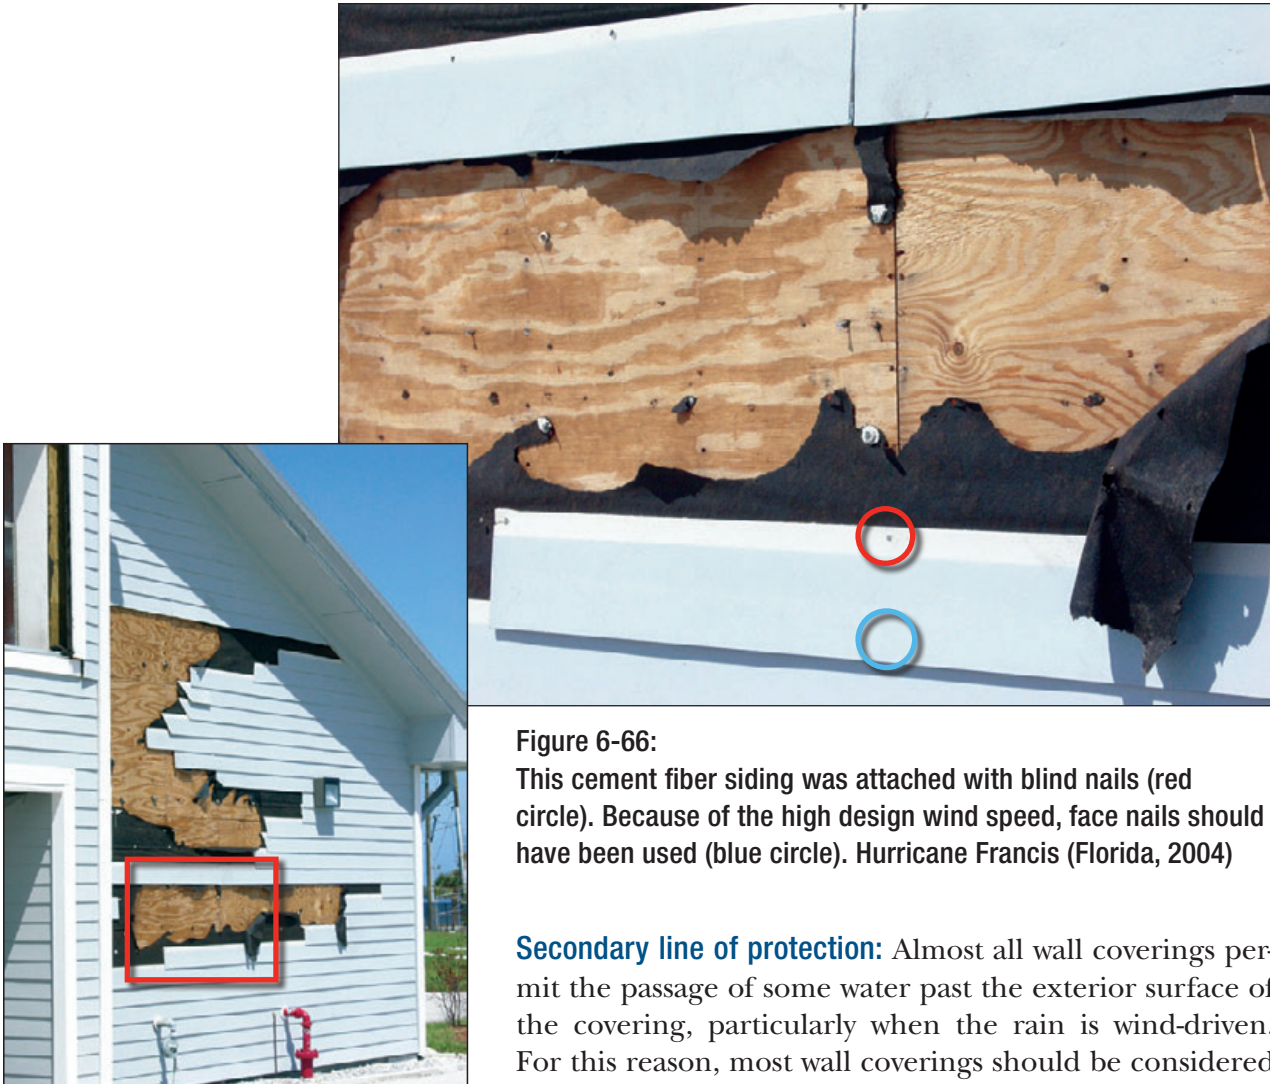
Figure 6-66:

This cement fiber siding was attached with blind nails (red circle). Because of the high design wind speed, face nails should have been used (blue circle). Hurricane Francis (Florida, 2004)

Siding: Vinyl siding blow-off is typically caused by nails spaced too far apart and/or the use of vinyl siding that has inadequate wind resistance. Vinyl siding is available with enhanced wind resistance features, such as an enhanced nailing hem, greater interlocking area, and greater thickness. In high wind regions, fiber cement siding blow-off is typically caused by the use of blind nails rather than face nails (see Figure 6-66). Where the design wind speed is low enough to use blind nailing, if blow-off occurs, it is typically caused by nails spaced too far apart and/or too close to the edge of the siding. Wood siding generally performs well in high wind events.

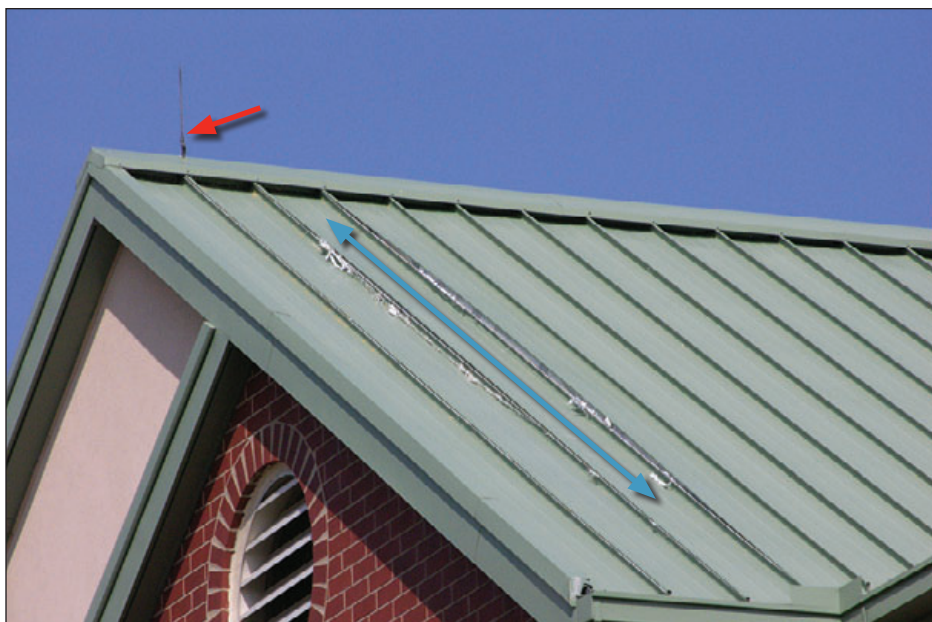
Figure 6-67:
Three of the panel ribs opened up (one to the right of the blue arrow and two to the left). The LPS conductor serving the air terminal (red arrow) ran underneath the ridge flashing. Estimated wind speed: 105–115 mph. Hurricane Ivan (Florida, 2004)

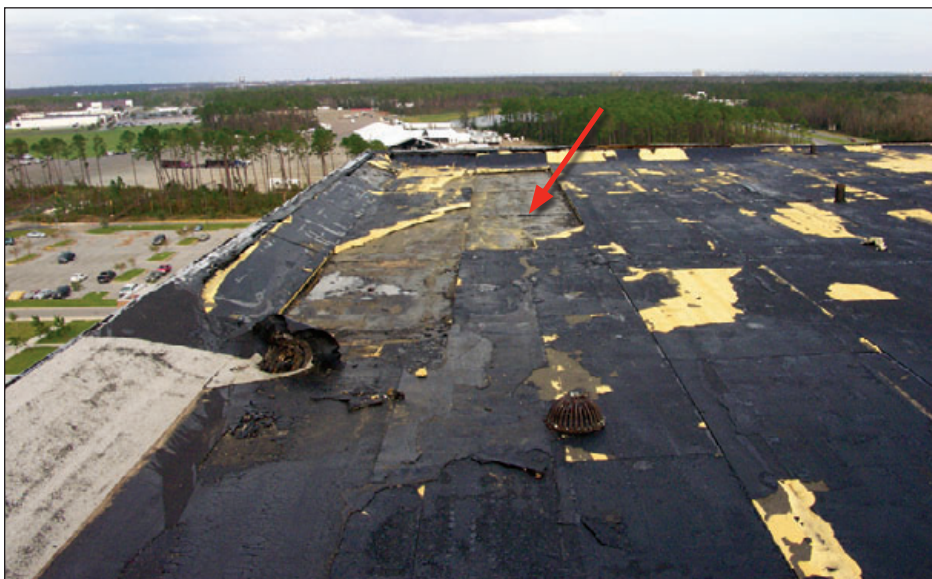
Figure 6-68:
The blown off insulation (red arrow) may have initiated blow-off of the roof membrane. Estimated wind speed: 105–115 mph. Hurricane Ivan (Florida, 2004)

When fully adhering insulation boards, it is recommended that the boards be no larger than 4 feet by 4 feet. It is also recommended that the board thickness not exceed 2 inches (1½ inches is preferable). Use of small thin boards makes it easier for the contractor to conform the boards to the substrate. At the building shown in Figure 6-68, 4-foot by 8-foot insulation boards were set in hot asphalt over a concrete deck. A few of the boards detached from the deck. The boards may have initiated the membrane blow-off, or the membrane blow-off may have been initiated by lifting and peeling of the metal edge flashing, in which case, loss of the insulation boards was a secondary failure.

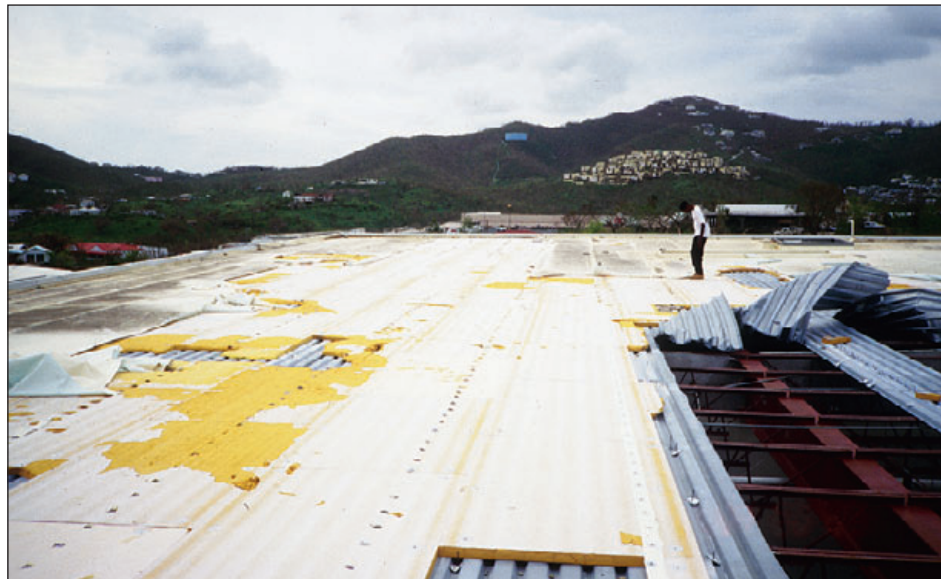
Figure 6-69:
The orientation of the membrane fastener rows led to blow-off of the steel deck. Hurricane Marilyn (U.S. Virgin Islands, 1995)

When specifying a mechanically attached single-ply membrane, if a steel deck is selected, it is critical to specify that the membrane fasteners be attached in rows perpendicular to the steel flanges to avoid overstressing the attachment of the deck to the deck support structure. At the school shown in Figure 6-69, the fastener rows of the mechanically attached single-ply membrane ran parallel to the

top flange of the steel deck. The deck fasteners were overstressed and a portion of the deck blew off and the membrane progressively tore. When membrane fasteners run parallel to the flange, the flange with membrane fasteners essentially carries the entire uplift load because of the deck's inability to transfer any significant load to adjacent flanges. Hence, at the joists shown in Figure 6-68, the deck fasteners on either side of the flange with the membrane fasteners are the only connections to the joist that are carrying substantial uplift load.

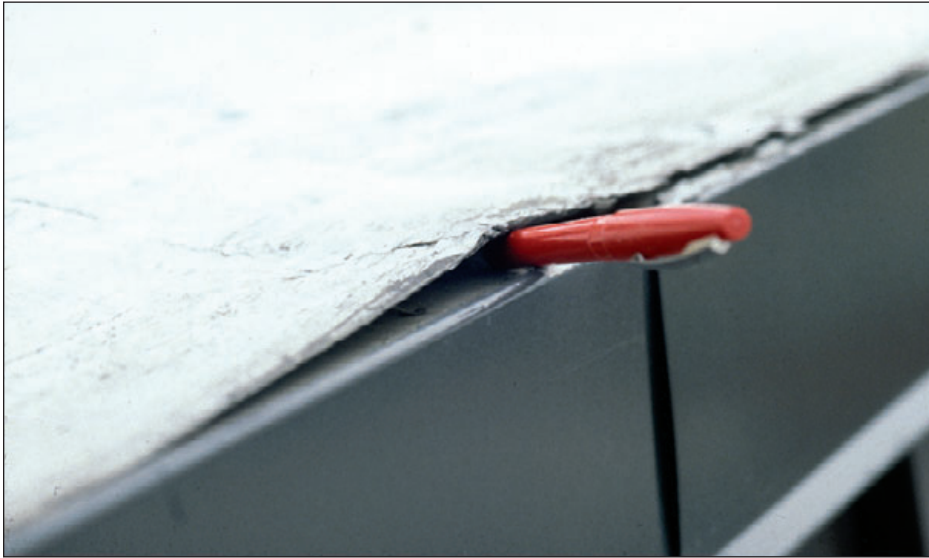
Figure 6-70:
The ink pen shows an opening that the wind can catch to cause lifting and peeling of the membrane.

Roof membrane blow-off is almost always a result of lifting and peeling of the metal edge flashing or coping, which serves to clamp down the membrane at the roof edge. Therefore, it is important for the design professional to carefully consider the design of metal edge flashings, copings, and the nailers to which they are attached. The metal edge flashing on the modified bitumen membrane roof shown in Figure 6-70 was installed

underneath the membrane, rather than on top of it, and then stripped in. In this location, the edge flashing was unable to clamp the membrane down. At one area, the membrane was not sealed to the flashing. An ink pen was inserted into the opening prior to photographing to demonstrate how wind could catch the opening and lift and peel the membrane.

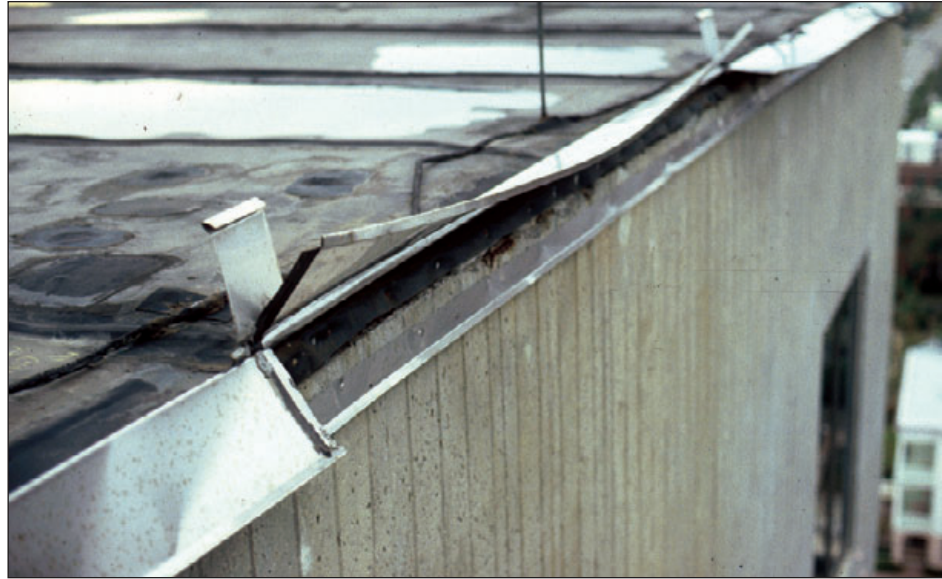
Figure 6-71:
The metal edge flashing on this building disengaged from the continuous cleat and the vertical flange lifted. Hurricane Hugo (South Carolina, 1989)

The traditional edge flashing/coping attachment method relies on concealed cleats that can deform under wind load and lead to disengagement of the flashing/coping (see Figure 6-71) and subsequent lifting and peeling of the roof membrane. When a vertical flange disengages and lifts up, the edge flashing and membrane are very susceptible to failure. Normally, when a flange lifts, the failure continues to propagate and the metal edge flashing and roof membrane blows off.

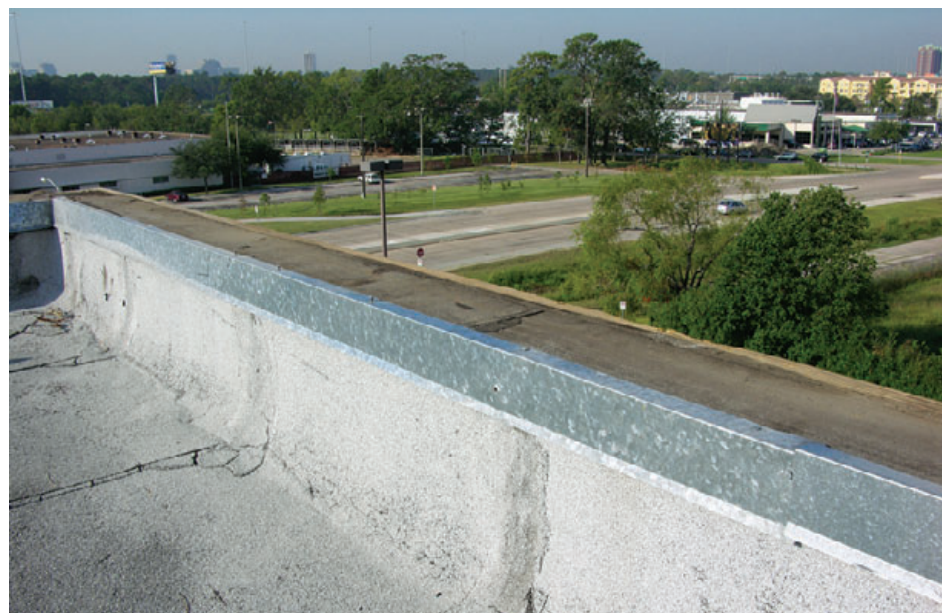
Figure 6-72:
The coping blew off because of inadequate attachment of the cleats. Estimated wind speed: 92 mph. Hurricane Ike (Texas, 2008)

At the building shown in Figure 6-72, the cleat nailing provided very little resistance to outward deflection of the cleat and coping. While most of the continuous inner and outer cleats remained on the building, several sections of coping and at least one cleat blew off once the amount of deflection was sufficient for the coping to disengage from the cleat. In this case, the roof membrane did not lift and peel as often happens when the coping blows off. However, the coping debris did gouge the roof membrane. Note that the base flashing was stopped at the top of the parapet. It should have been run across the top of the nailer and turned down and nailed so as to provide greater watertight protection in the event of coping leakage or coping blow-off.

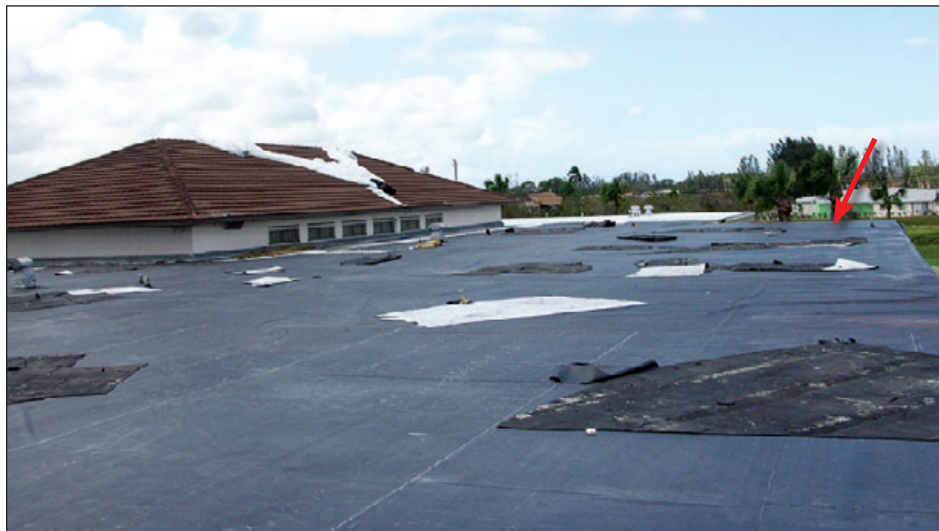
Figure 6-75: The original modified bitumen membrane was blown away after the gutter lifted in the area shown by the red arrow (the black membrane is a temporary roof). Hurricane Francis (Florida, 2004)

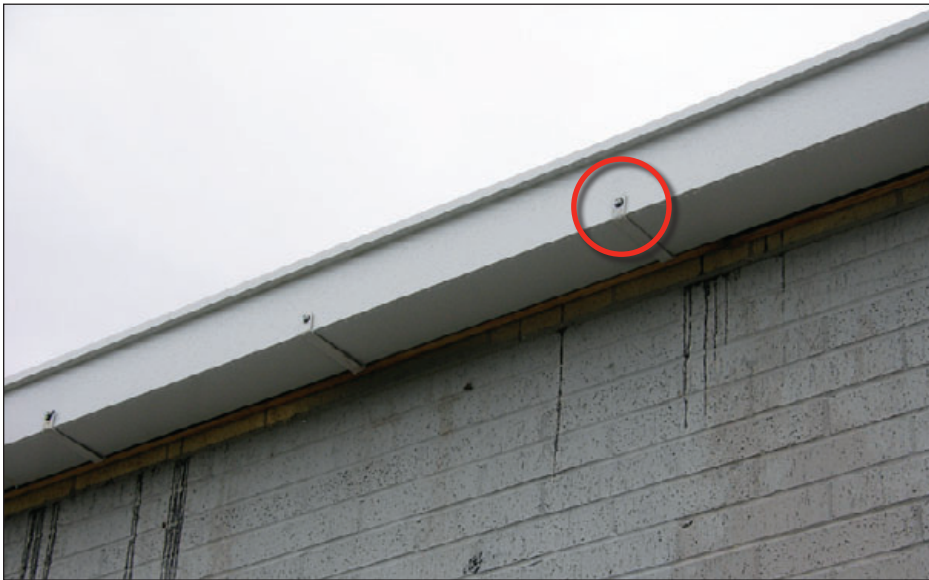
Figure 6-76:

At this gutter, a fastener connected the bracket to the gutter. Note: To avoid leakage at the fasteners between the bracket and gutter, the bracket should extend near or to the top of the gutter so that the fastener would be above the waterline. Estimated wind speed: 95 mph. Hurricane Ike (Texas, 2008)

- Gravity-support brackets can be designed to resist uplift loads. In these cases, in addition to being attached at its top, the bracket should also be attached at its low end to the wall (as was the case for the brackets shown in Figure 6-74). The gutter also needs to be designed so it is attached securely to the bracket in a way that will effectively transfer the gutter uplift load to the bracket (see Figure 6-76). Bracket spacing

will depend on the gravity and uplift load, the bracket's strength, and the strength of connections between the gutter/bracket and the bracket/wall. With this option, the bracket's top will typically be attached to a wood nailer, and that fastener will be designed to carry the gravity load. The bracket's lower connection will resist the rotational force induced by gutter uplift. Because brackets are usually spaced close together to carry the gravity load, developing adequate connection strength at the lower fastener is generally not difficult. Screws rather than nails are recommended to attach brackets to the building because screws are more resistant than nails to dynamically induced pull-out forces.

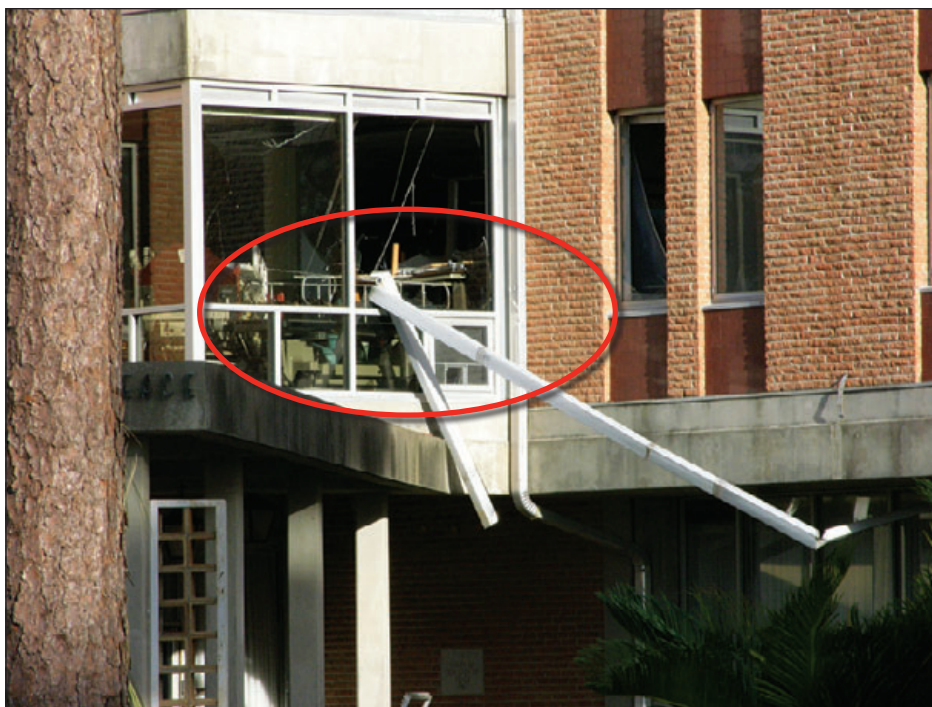
Figure 6-78:
Blow-off of this
downspout resulted
in glazing breakage.
Estimated wind
speed: 105–115 mph.
Hurricane Ivan (Florida,
2004)

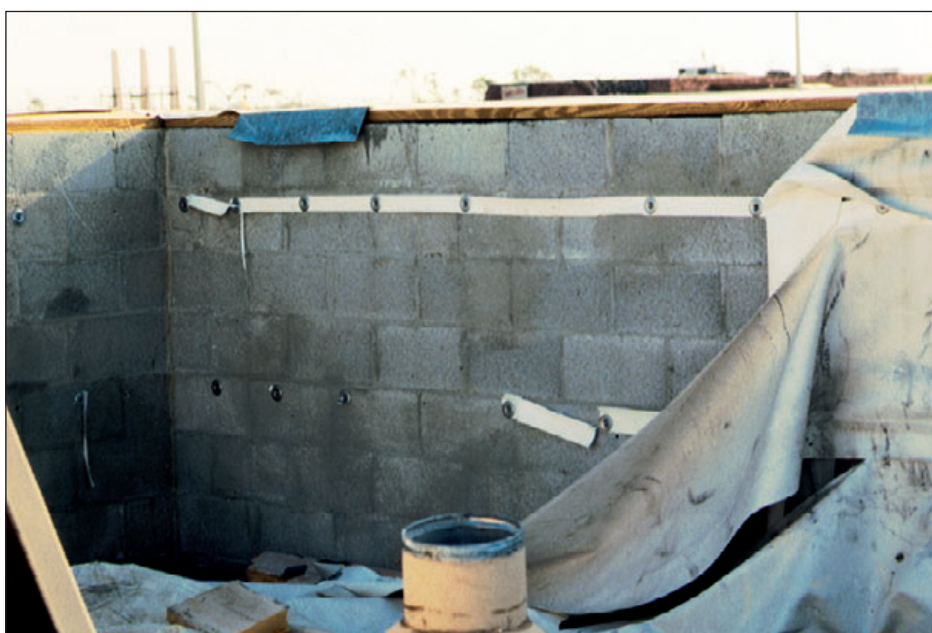
Figure 6-79:
If mechanically attached
base flashings have
an insufficient number
of fasteners, the base
flashing can be blown
away. Hurricane Andrew
(Florida, 2004)

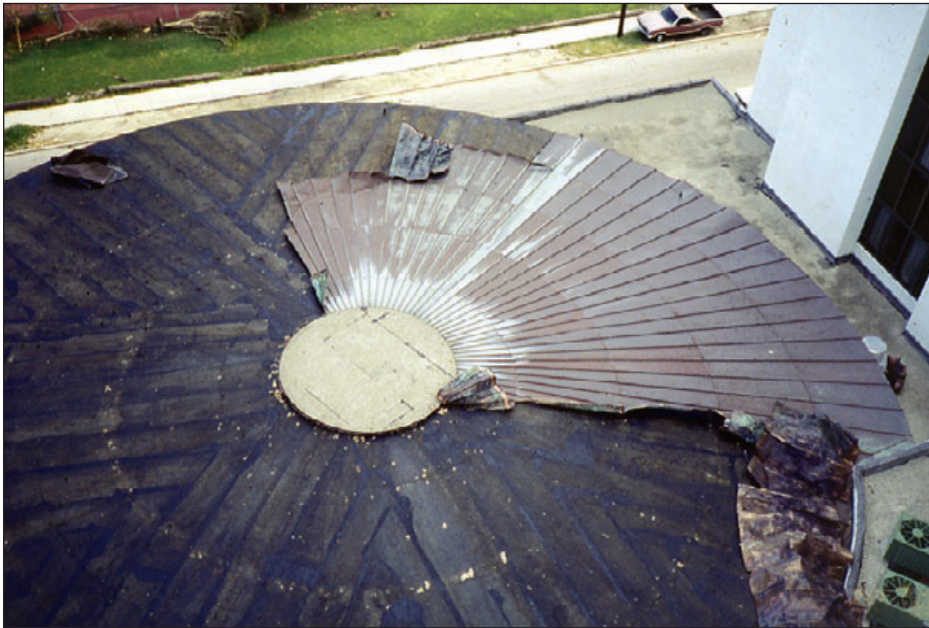
Figure 6-80:
The secondary membrane prevented significant leakage into the building after the copper roof blew off. Hurricane Andrew (Florida, 1992)

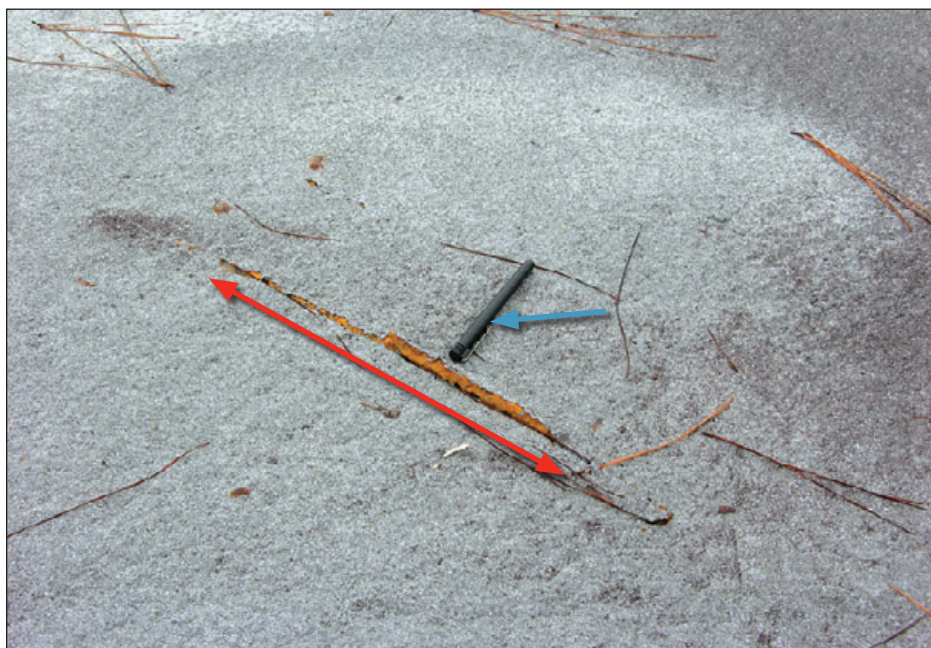
Figure 6-81:
Although a missile cut into the SPF, the roof was still watertight. The ink pen (blue arrow) shows the relative size of the impact area. Estimated wind speed: 110 mph. Hurricane Ike (Texas, 2008)

With SPF, missiles can gouge the foam (as shown in Figure 6-81), but it is rare for missiles to completely penetrate through the foam. When a quality SPF is gouged, only an insignificant amount of moisture is absorbed into the foam cells at the gouged area, even if the gouge is not repaired for several months.

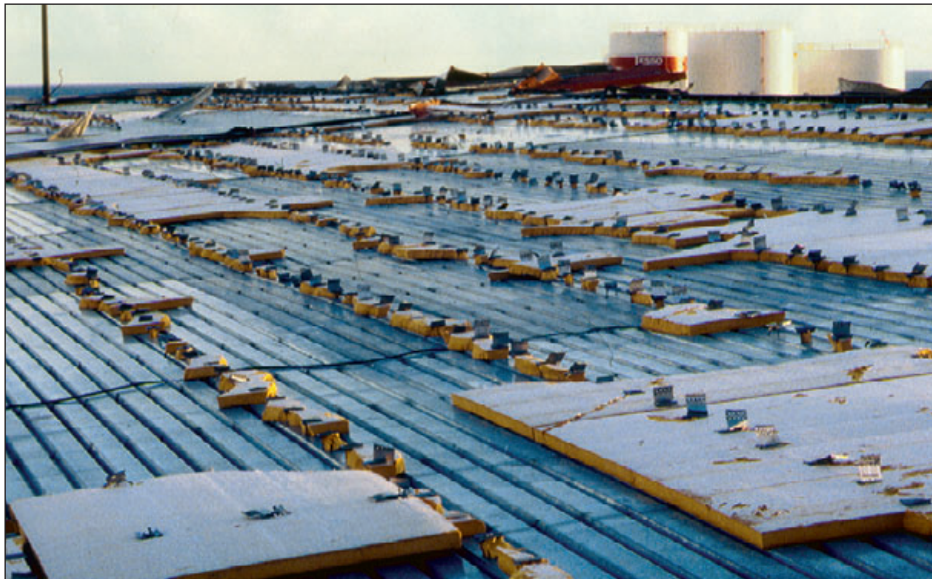
Figure 6-82: Significant interior water damage and facility interruption occurred after the standing seam roof blew off. Hurricane Marilyn (U.S. Virgin Islands, 1995)

If the metal panels are blown off or punctured during a hurricane, the secondary membrane should provide watertight protection unless the roof is hit with missiles of very high momentum. At the roof shown in Figure 6-82, the structural standing seam panel clips bore on rigid insulation over a steel deck. Had a secondary membrane been installed over the steel deck, the membrane would have likely prevented significant interior water damage and facility disruption.

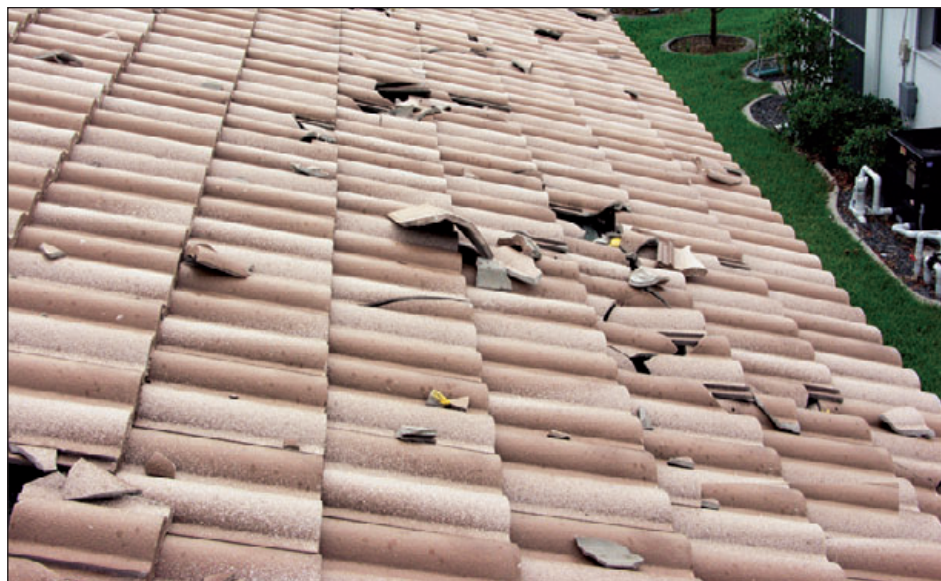
Figure 6-83:
Brittle roof coverings, like slate and tile, can be broken by missiles, and tile debris can break other tiles. Estimated wind speed: 140–160 mph. Hurricane Charley (Florida, 2004)

The tiles shown in Figure 6-83 were attached with the foam-adhesive (adhesive-set) method. The tiles shown in Figure 6-84 were attached with the wire-tied method (an uncommon method in the eastern portion of the United States). In addition to the wire attachments, the tiles were also attached with stainless steel clips at the first three rows from the eave. All of the tiles had tail hooks, and adhesive was used between the tail and head of all tiles. Except for the three perimeter rows which were clipped, the wires did not prevent the tiles from lifting a short distance above the concrete deck. The failure was attributed to tiles lifting and then slamming back down on the deck, where upon they broke and the tile fragments blew away.

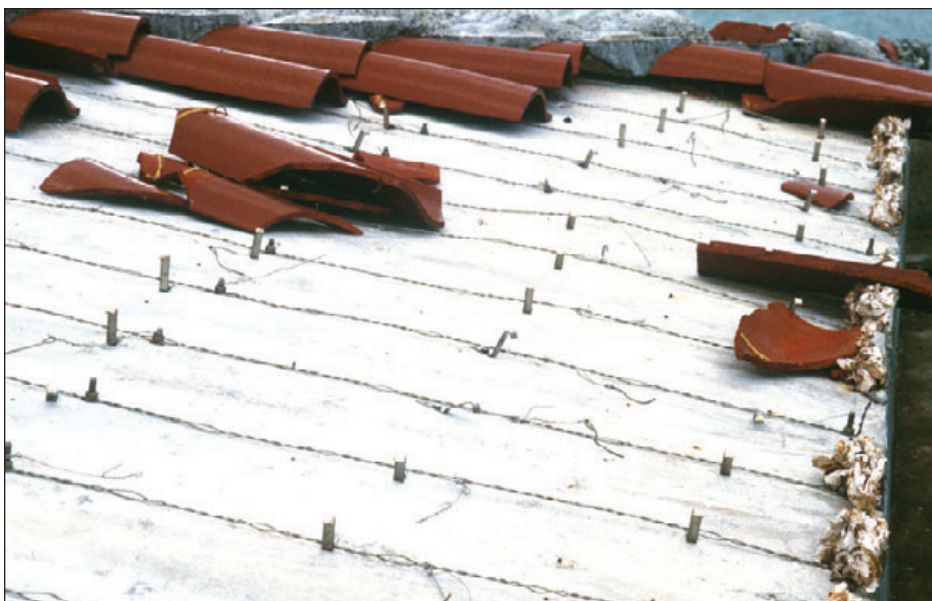
Figure 6-84
These wire-tied tiles were installed over a concrete deck. The failure was attributed to lack of vertical restraint, which allowed the tiles to lift and then be broken when they slammed back down onto the deck. Typhoon Paka (Guam, 1997)
